### Service Bulletin

#### Arc Fault Detection and Troubleshooting

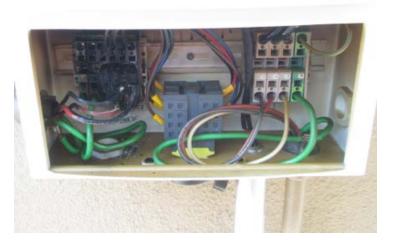
All of these are common conditions and easily identified with a quick visual inspection. First of all, arcing leaves some evidence. The may be *discoloration of wiring and racking, melted connectors and insulation* or even *burned junction boxes* on the *back of panels*. A quick visual inspection can locate such issues very reliably. A *gentle tug on DC cables* whether in the home run connections, *panel to panel connections* or in the combiner/wiring box can locate wires that have loosed or were not terminated properly. The below picture is an example of improperly terminated DC connections in a wire box and blindly resetting an Arc Fault without verifying all DC connections. The DC circuit includes all connections, even those in the inverter.

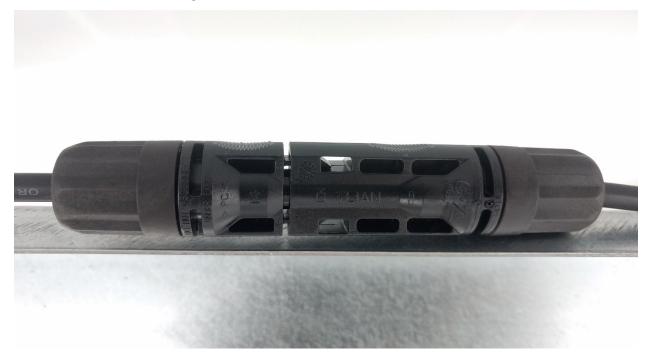
Bad crimp connections or connections that are not fully mated can be found using the same tugging method. Do not just concentrate on field installed connectors. There have been many instances where the factory crimp connection on the PV panel were the cause of arcing issues. The same goes with the PV junction boxes. Damage can happen between the factory and the site or the diodes can fail both which can cause serial arcing and trigger an arc fault. The visual method is very easy, does not require special tools and is effective at pinpointing the failure to a component. An example of connections not mated and causing arc faults is shown below.
